EMSWORTH LOCKS AND DAMS OHIO RIVER MAJOR REHABILITATION EVALUATION REPORT

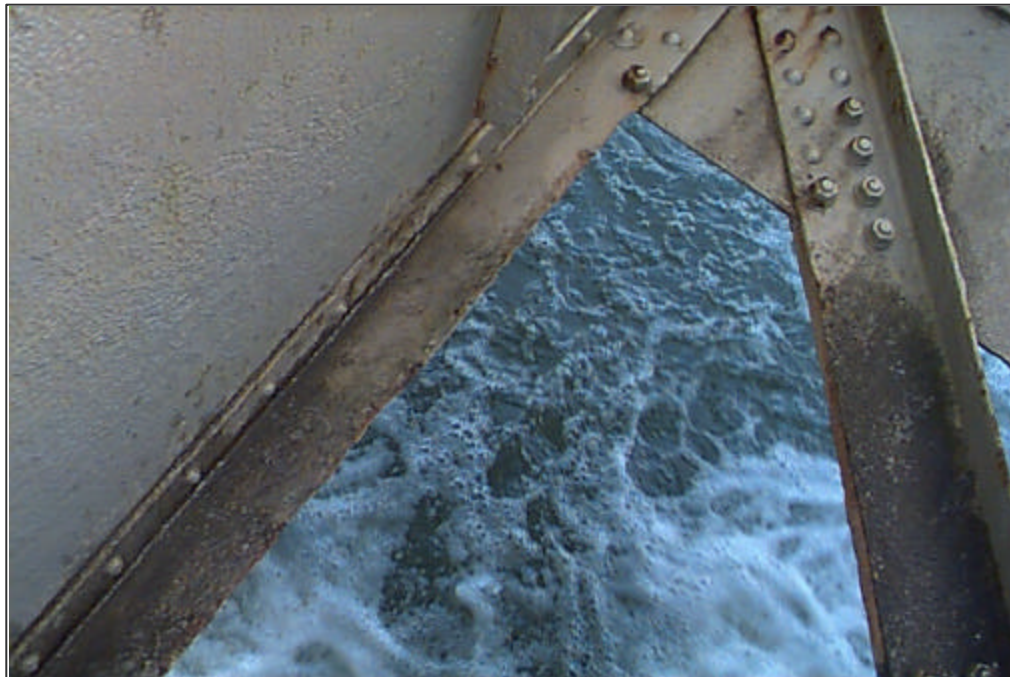
The truss members of all dam gates are in an advanced stage of corrosion and operational difficulties continue to occur despite the renovation work in the 1970's and subsequent work performed during the major rehabilitation. Truss members in the lower portions of these gates are within the splash zone and are subject to severe corrosion. Recent inspection and measurement of lower steel truss members show numerous components are corroded such that less than 50% of the original member remains. An example of this corrosion is provided

in Photo IV-1. This situation is complicated by the fact that the design of the gates provides no allowance for runaway barge or ice impact loading. If such loading were to occur, these gates would be likely to fail.

Photo IV-1. Corroded Dam Truss Members. (Note rivets replaced with nuts/bolts during rehabilitation in the 1980s)

Maintenance of these members is extremely difficult due to factors such as accessibility, the sheer number of truss members per structure and harsh corrosive environment. Between 1973 and 1980, deteriorated diagonal truss members were replaced at the same time as the gates were being converted to non-overflow mode only. Ironically, these new members were found to be corroded during inspections only a few years later (prior to the major rehabilitation).

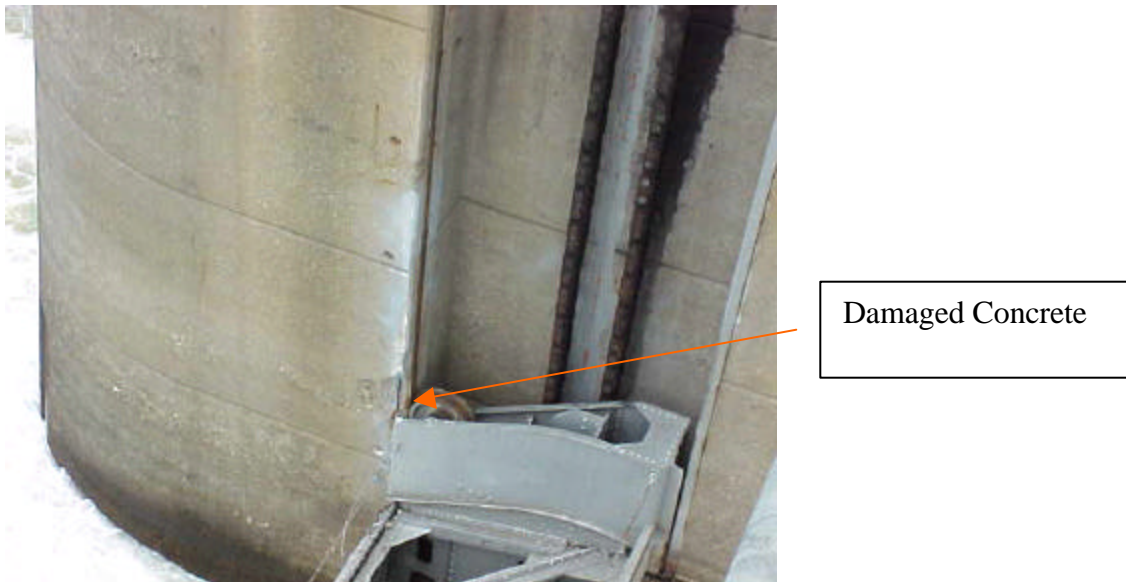
During a routine inspection in October 2000 a new problem surfaced. The wheels in the truck assembly for Lift Gate #6 had moved out of position by disengaging from the metal tracks, causing the gate structure to slide against the pier. To prevent further damage to the gate and dam pier, the lift gate was taken out of service. A repair crew jacked the gate upstream and forced the wheels back into the guide track. The bulkheads were removed and the lift gate was operated, but after a few feet of travel the wheels again moved out of the guides. The exact cause of this problem has not yet been determined, and Gate #6 remains out of operation at this time. One such truck assembly that came out of the track, thereby taking the gate out of operation, is shown in Photo IV-2.

To date, all the failures have been on the lower truck assemblies. However, the District has similar concerns about the upper truck assemblies. It can be expected that within the next ten years components of these assemblies will also need to be renovated or failures will begin to occur.

Photo IV-2 - Wheel Truck Out of Track at Pier No. 2. Note abrasion damage to concrete on corner of pier

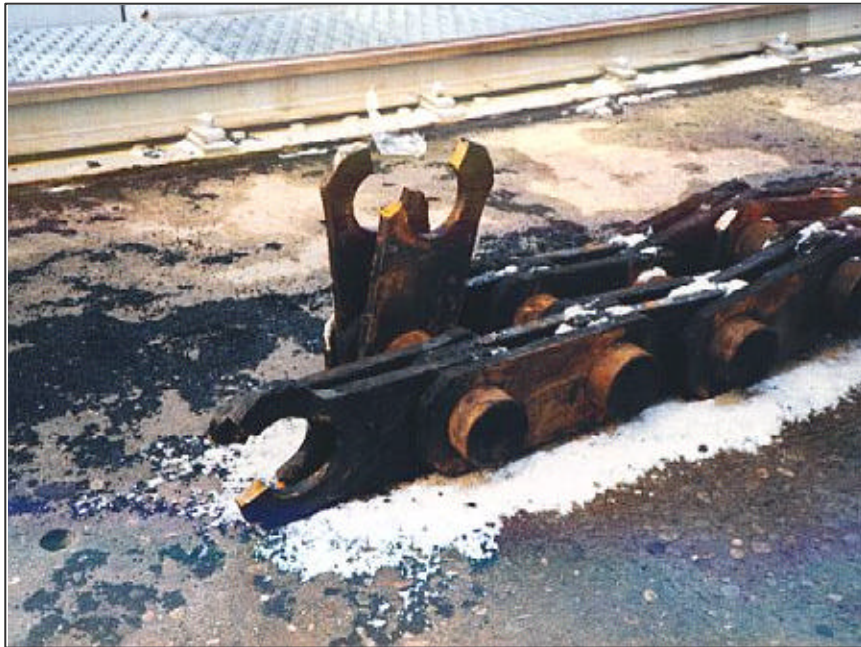
The large link type chains are difficult to maintain because there is no means of greasing the inner contact surfaces, which has resulted in problems with frozen links that do not wrap properly around the sprockets. Grease is periodically painted on the exterior of the chain to keep it from corroding but the thick grease build up only makes it difficult to inspect for wear and damage. These chains are also corroded and dry, and chains tend to kink and remain kinked even under load.

Before visual inspection was instituted, the system failure caused vertical lift gate #14 to drop twice, in November 1972 and February 1988, requiring repairs that, in 2001 dollars, would equate to \$1.1 million and \$120,000, respectively. Photo IV-3 shows the broken chain and Photo IV-4 focuses on a damaged truck assembly, both caused by the 1988 event. These events occurred prior to the dedication of operations staff to visually inspect gate

Photo IV-3 - Broken chain resulting from dropped gate, February 1988

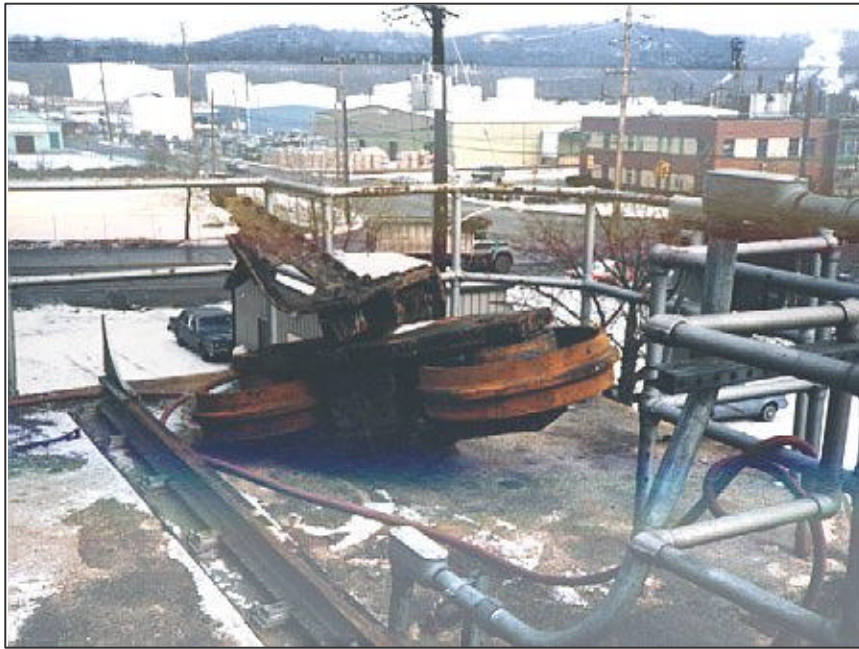
Photo IV-4 - Damaged lower wheel truck, Gate #14, resulting from dropped gate, February 1988.

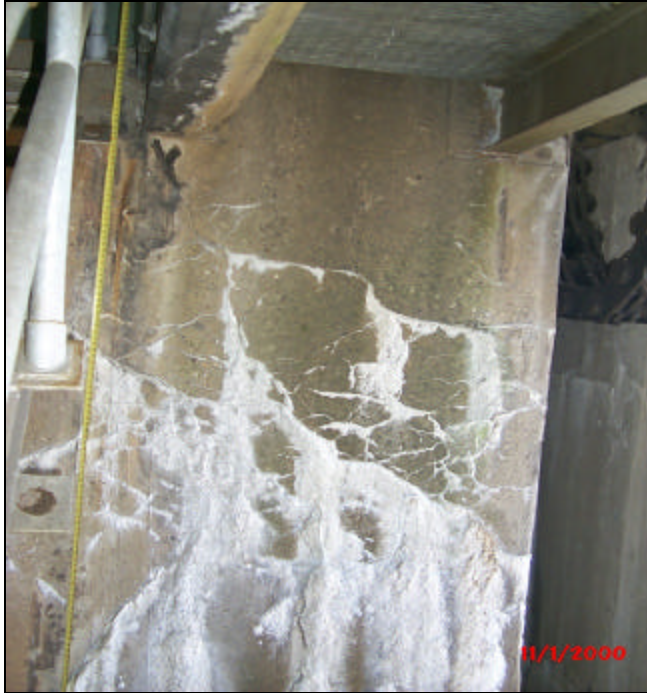
While the concrete in the dam piers is generally in good to fair condition, it shows advanced deterioration in localized areas. The top surface and areas on the vertical surfaces of Piers 6, 7, 8, and 9 of the main channel dam, and Piers 12 through 16 of the back channel dam contain deteriorated concrete in poor condition. The top surface deterioration consists of fine-to-wide random cracking, medium scaling, and small spalling, predominately in the downstream section of the piers. Spalling is generally adjacent to the girder supports. Many of the seats are corroded, and staining can be seen on the horizontal and vertical surfaces of some piers. Corrosion of the anchorage is a possible cause of the spalling. The damaged areas on the vertical surfaces exist on the land and river sides of the piers and extend 8' to 10' below the top of the pier. The concrete in these damaged zones is considered to be in an advanced stage of deterioration. Also, concrete has deteriorated to such a degree around the wheel guides of Gate Bay 14 that the vertical-lift gate has become dangerous to operate for fear of failure. Photo IV-5 shows a dramatic example of damaged concrete on one of the main channel piers.

Photo IV-5. Heavy Cracking with Efflorescence on Downstream Pier Stem.
